### The Early Years

## Development of British Signalling - Part II. Ken Chynoweth

### Forwards From the Early Years

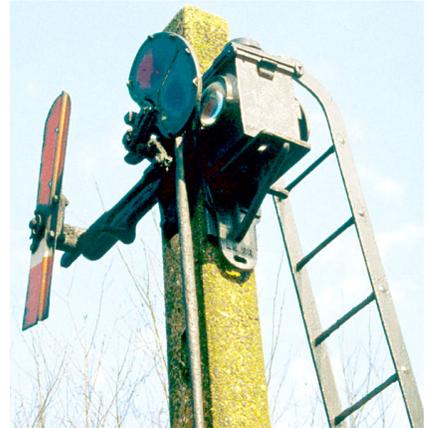
*Somersault signal with the arm in the clear position.  
<http://www.roscafen.com/signals/Lincoln/WestHolmes.htm>*

To prevent snow giving a false indication by holding down a semaphore arm, the Great Northern Railway experimented with a centrally balanced arm linked to the spectacle glass on the side of the post. This was known as the "somersault" signal and persisted on Great Northern lines for many years. Other railways also abandoned slotted post signals but opted for the more conventional arrangement of mounting the arm on a simple pivot outside the post. Initially these worked in the lower quadrant showing a red light for danger but continued to exhibit a white light for clear. As this could cause confusion with the increasing use of street lighting the white signal lights were gradually replaced with green to indicate clear.

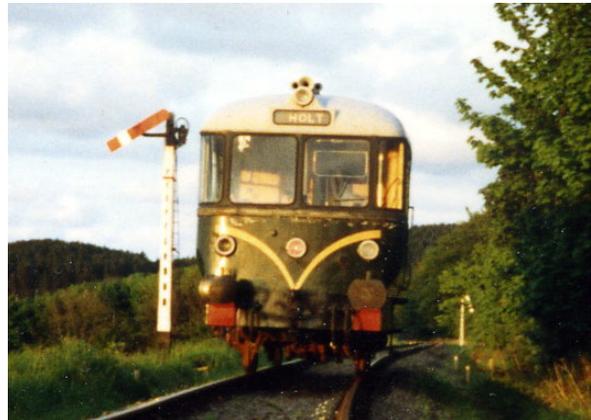
*Somersault signals are a particular favourite of mine, being quite widespread in use on the M&GN [Ed.] Here we have two between Weybourne and Holt on the North Norfolk Railway.*
